Modelling of the HMAS Westralia Fire

DSTO-TR-0698

MODELLING OF THE HMAS WESTRALIA FIRE

The HMAS Westralia fire incident of 5 May 1998, involved the combustion of a quantity of diesel fuel in the engine compartment. Four sailors were killed and the ship disabled.

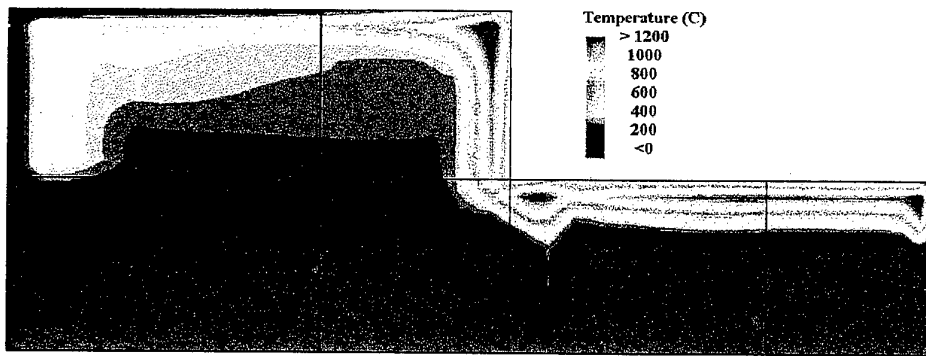
The flow of heat to the diesel generators is also of some concern. Figure 11 shows the predicted temperature distribution of the fire incident after 1 minute. The figure shows an aft to forward section through the origin of the fire. The bottom of the picture corresponds to the top of the starboard engine. The temperatures in the area of the diesel generators remain near ambient. However the area near the cargo pumps at the forward bulkhead are subjected to significant heat loading at levels corresponding to the top of the pumps.

Figure 11 shows the predicted temperature distribution of the fire incident after 1 minute. The figure shows an aft to forward section through the origin of the fire. The bottom of the picture corresponds to the top of the starboard engine.

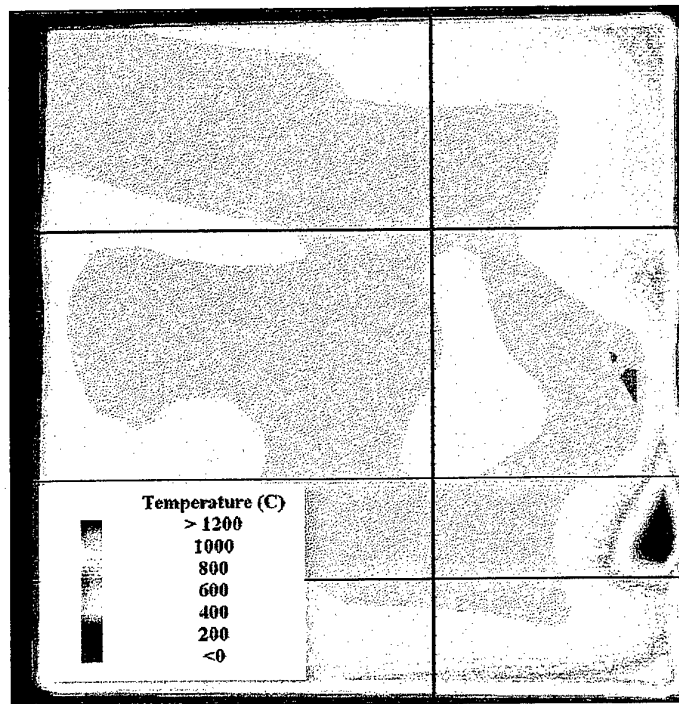
The firefighting team, from the level of the fridge flat, attempted re-entry into the engine compartment. This level refers to the top platform at the aft end of the compartment. The platform can be seen in Figure 2 just above the boiler. The predicted temperatures on the fridge flat level, depicted in Figure 13, one minute into the incident indicate that there is significant heating across the whole of this area. Temperatures are predicted to be near 350°C. The predicted temperature four minutes into the event is shown in Figure 14. Temperatures are predicted to have fallen to 100°C. At four minutes, this is still too hot for an attempted reentry [9]. The observed damage at the fridge flat level is again consistent with the predicted temperature history (light fittings melted and little damage to paint work)

Figure 13. The temperature distribution one-minute into the fire incident at the level of the fridge flat.

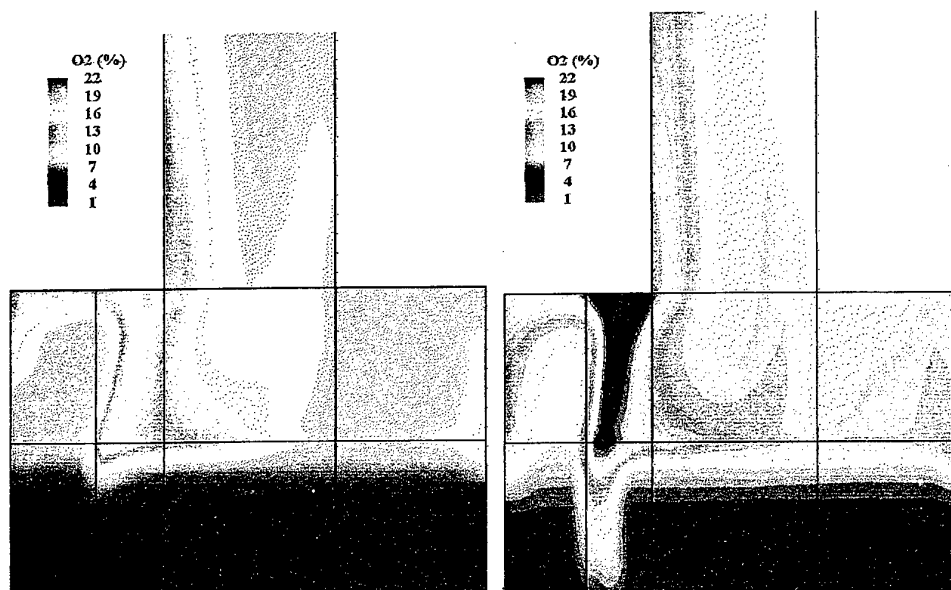
The oxygen content of the compartment is shown in Figure 15 for a section across the compartment just aft of the MCR looking aft at 30 and 60 seconds into the fire. The starboard side shows the depleted air associated with the fire plume rising rapidly up the starboard side of the stack. The port side shows a depleted oxygen level within a minute as smoke fills the whole compartment. The carbon dioxide level in the model, shown in Figure 16, has filled the compartment with levels of up to 10% CO₂ down below the MCR within a minute. The CO₂ distribution matches the oxygen loss distribution well indicating that in the model fire the fire was well ventilated.

Figure 15. Calculated oxygen content 0.5 minute and 1 minute into the fire incident. A cut across the compartment aft of the MCR is shown looking aft. The bottom of the picture corresponds to the level at the top of the engines. The horizontal line in the middle of the picture is at the level of the MCR. Low concentrations of oxygen are predicted at the top of the escape ladder

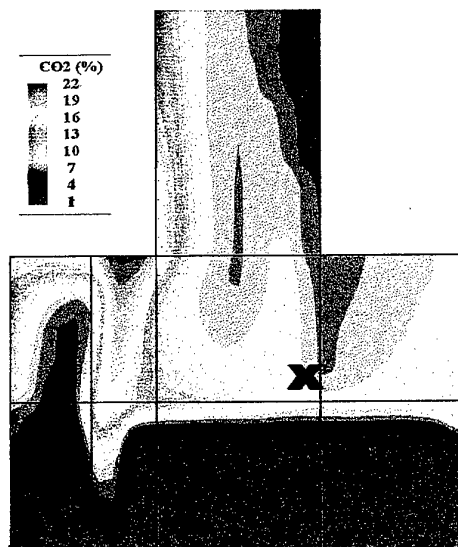
Figure 16 Calculated carbon dioxide levels 1 minute into the fire incident. A cut across the compartment aft of the MCR is shown looking aft with the same geometry as in Figure 15. High concentrations of CO_2 are predicted at the top of the port escape ladder at the level of the MCR, (marked with an X).

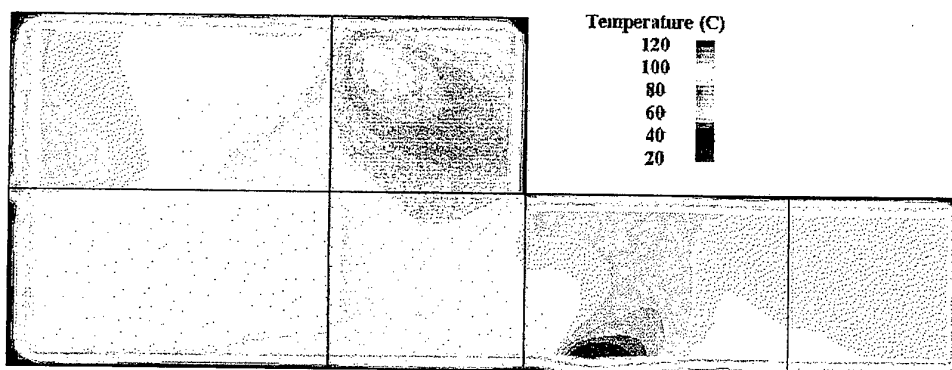
In the modelled scenario the fuel source is removed 1 minute into the event and the compartment is allowed to cool. A longitudinal compartment section through the origin of the fire is shown, in Figure 17, four minutes into the event. The temperature in the region of the cargo pumps and the diesel generators on the lower platform has reduced significantly over the temperature after one minute and become evenly heated at about 100°C. Cool air can be seen to be flowing down from the stack just aft of the MCR.

Figure 17. The predicted temperature distribution is shown for a section through the origin of the fire three minutes after the fuel supply is cut to the fire.

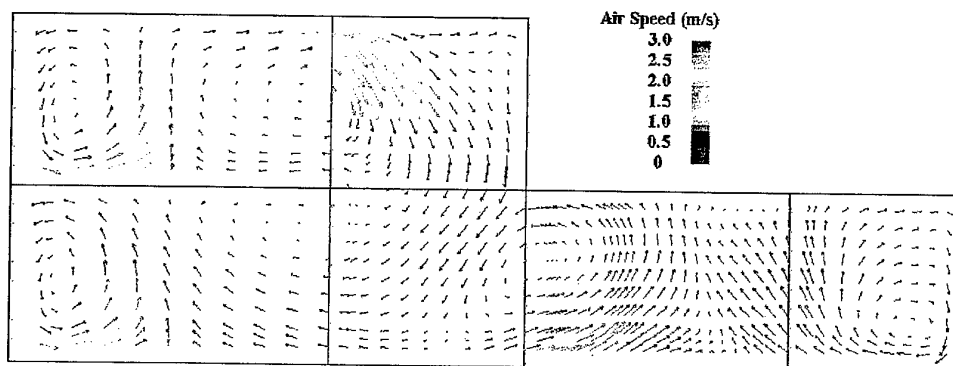
The predicted flow pattern depicted in Figure 18, shows a series of slowly swirling eddies supported by convective gas flows caused by heat losses to the compartment walls and to the atmosphere through the opening at the top of the stack.

Figure 18. The residual airflow for the simulated incident is shown for a section through the origin of the fire. The downward flow of cool air from the open stack and the associated circulations are clearly visible.

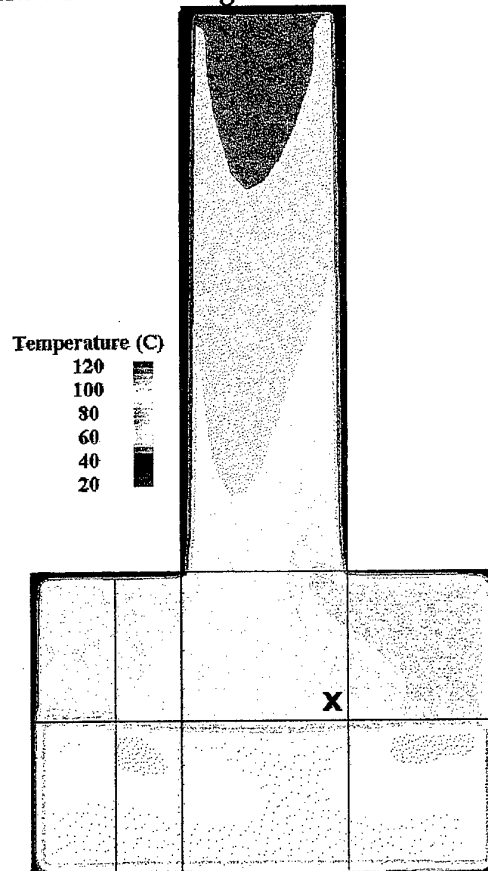
The stack provides the main flow of heat out of the compartment. The large surface area of the stack allows conduction to cool the air and the opening at the top of the stack allows warm air to leave compartment, which is replaced by a down flow of cool air into the compartment. Figure 19 shows the predicted temperature distribution for a cut just aft of the MCR four minutes into the event. Temperatures in the compartment at the level of the MCR and below remain at levels considered too high for firefighting above 80°C [9]. Cool air from the stack has penetrated to the region of the top of the port escape ladder, marked with an X in Figure 19.

Figure 19. The predicted temperature distribution is depicted for a section just aft of the MCR, facing aft, four minutes into the modelled incident. The blue area corresponds to a downdraft of cooler air flowing back down the stack. The x marks the location of the top of the port escape ladder.

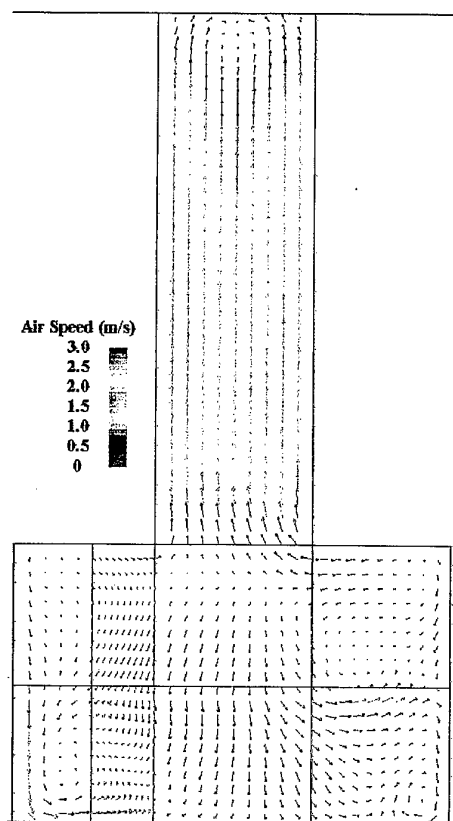
Four minutes into the event the airflow in the lower sections of the compartment is no longer driven by the heat of the spray fire but is driven by convective eddies created by the cool hull locally cooling the air. The upper section of the compartment is still subjected to convective cooling as warm air escapes up the stack. Figure 20 shows the predicted airflow at 4 minutes for a section just aft of the MCR looking aft. The flow up the stack is linear in this section and upward. However sections further aft reveal a complex flow of warm air rising and cool down drafts.

Figure 20. The air speed is shown to the same section as in previous figure. The velocities are generally low less than 1.0 m/s except in the region of the stack. Convective eddies driven by the cool hull provide the main flow in the compartment below the level of the MCR.

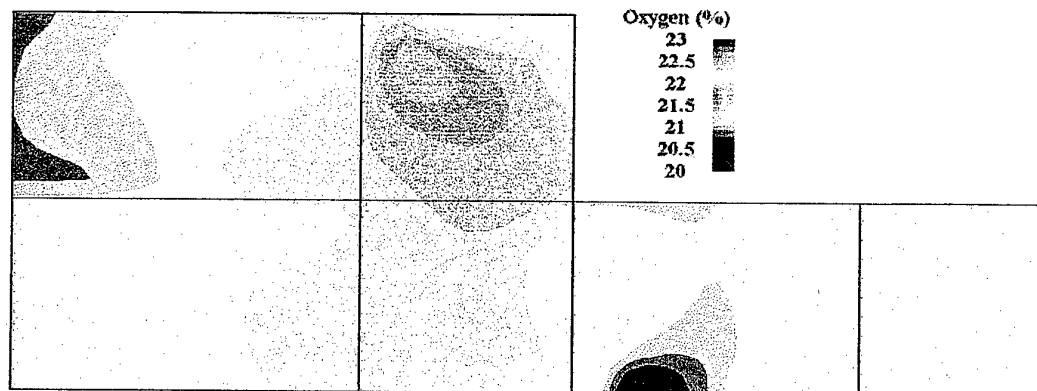
The oxygen level in the compartment four minutes into the modelled event shows the levels to be only 10% less than normal. The levels being most depressed near the fire origin and at the fridge flat. Figure 21 shows the predicted oxygen levels at four minutes for a section through the fire origin.

Figure 21. The predicted oxygen levels for a section through the fire origin is shown.

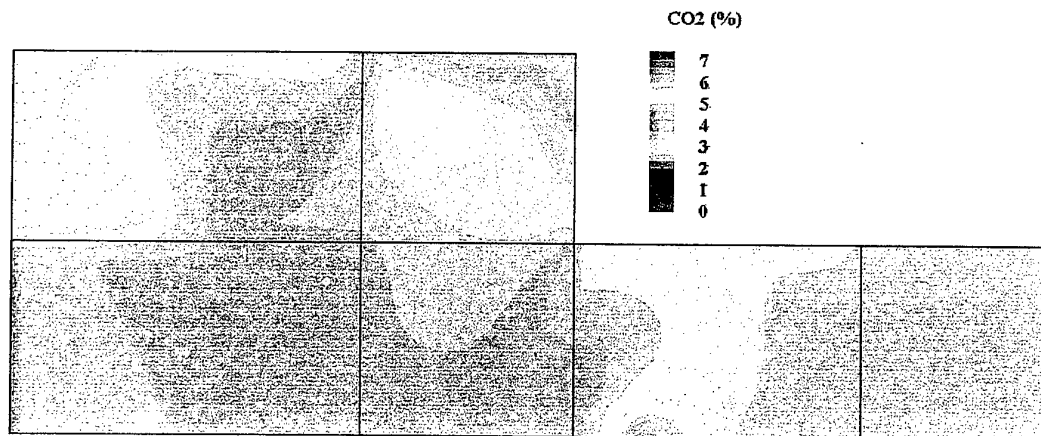
The level of CO₂ throughout the compartment is still high indicating mixing of the combustion products with the inflowing air. The levels are highest near the origin of the fire and at the fridge flat, see Figure 23. The effect of the down flow of fresh air from the stack can be seen in the area aft of the MCR as a reduced concentration of CO₂.

Figure 23. The levels of CO₂ are shown for a forward-aft section through the fire origin. The effects of residual fuel can still be seen near the fire origin. The rest of the compartment shows an even level of CO₂ at about 4%. The effect of the inflow of clean air down the stack is evident.
